Torsten Fischer of Krieg + Fischer Ingenieure discusses an accident investigation involving a destroyed gas holder roof on top of a digestate storage tank at a biogas plant in Germany

First-person sleuthing – destroyed gas holder roof

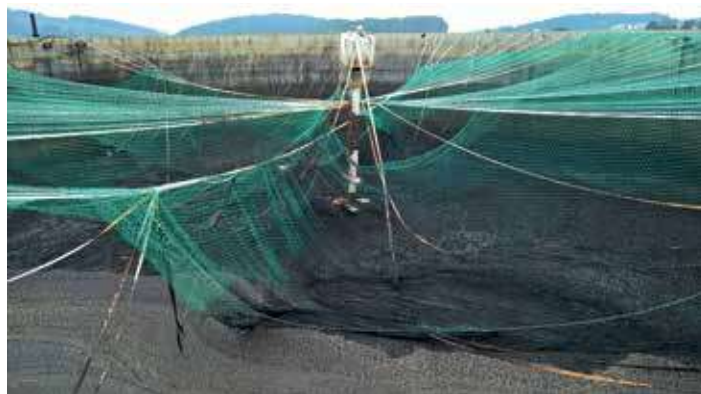
Figure 2: Fully visible centre column, crooked, with massively deformed stainless steel construction on top. Tank still filled with about 1 m of digestate. Net and some belts lying in the digestate

On site, the situation was a mess. With the two membranes already being removed, the situation that we found showed the centre column with its unique design was crooked (see Figure 2); dozens of belts from the roof's under-structure were either cracked or hanging loose or lying in the digestate (see Figure 3); the net from the roof's under-structure was torn, partly hanging at the tank wall and partly hanging loose, (see Figures 1-3).

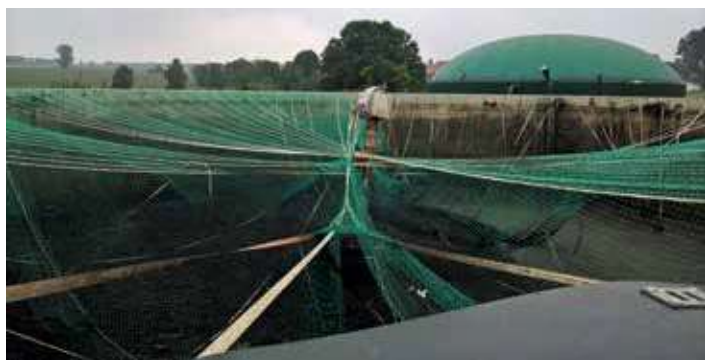
came down, the centre column crooked, and the mixers blocked as seen in Figure 1.

Figure 1: Looking into the digestate storage tank. The gas holder roof membranes already removed. Belts, net, crooked centre column. Background right hand side: secondary digester tank with double membrane gas holder roof

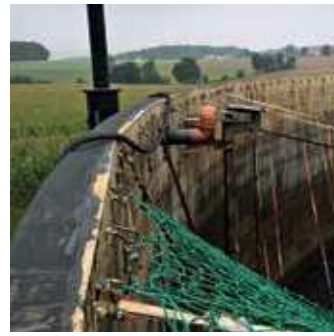
Figure 3: Tank wall with belts still fixed at the wall. Most belts in this area cracked and hanging into the digestate. Left hand side: overpressure/vacuum valve with related outflow pipe (in orange) and mast for submerged mixer next to it

1. Figure 3 shows the outflow pipe for the overpressure/vacuum device, with the lower part of the pipe entrance being well underneath the tank wall level. At least once in its lifetime the tank was overfilled and the pipe

flooded. We could not verify that the functionality of the overpressure/vacuum valve was given afterwards.

As a matter of fact, many cable ties broke as many belts hung around loosely,

(see Figure 3). Due to the geometry in the tank, it must have been one of the additional six belts that was first caught by the mixer. The final result was that during the minute-long test of each of the mixers outside and above the substrate in the tank, back in spring and summer 2016, vibrations led to the failure of the cable ties and the loosening of the belt-ends. During the test-run, the mixer tore the fixing plate of the (first) additional belt out of the wall, rolled up the belt and tore the centre column towards the mixer. Next, the two additional belts opposite the mixer were torn apart. Slowly, the stainless steel structure with the mushroom head was deformed and began to bend down. Due to the (over-) stretching and relaxing of the belts and rasping over the concrete structure or scratching along sharp steel parts, the belts were – finally – cut. The ongoing stressing of the whole structure, regular belts and additional belts including

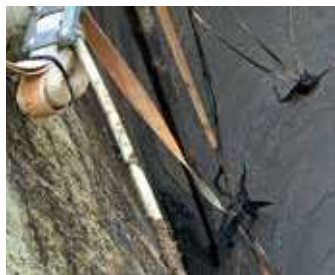
Figure 4: Belts wound around submerged mixer. Top left hand side: belt package with cable tie. For more details details, see Figure 5

5. In all three submerged mixers we discovered belts wound up (see Figure 4). We scrutinised the structural calculations. The concrete works on its own clearly followed the assumptions in the calculations. But something was different: in Figure 8, five belts can be seen fixed at the stainless steel construction, with the sixth being buried underneath the bent steel construction on the left hand side. What are these six belts? No such belts are included in the structural calculations, nor in any other documentation. Our best guess was that these six belts were used during assembly. After the centre column had been built, these six belt connections were the first ones assembled and they stabilised the whole construction during further assembly.

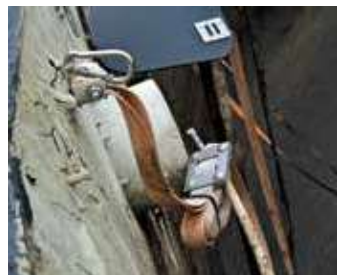
Figure 5: Belt package fixed with cable tie – located directly next to mixer mast. Belt fixed at wall. Snap hook for fixing net

We found another key detail: originally, the belts were too long for the diameter of the tank. Instead of cutting the excess length, during assembly, the workers rolled them up and fixed the rolls with cable ties, (see Figure 5). The overlength was about 3 m for each of the regular belts, and somewhat shorter for the six additional belts.

Cable ties are not supposed to be used in a biogas atmosphere or in such tanks, as they age and embrittle. As a result, after years, the cable ties break, the belt package unfolds, the belts hang around loose. Of course, it could also be that not all belts had been wound up properly, some may not have been wound up at all.

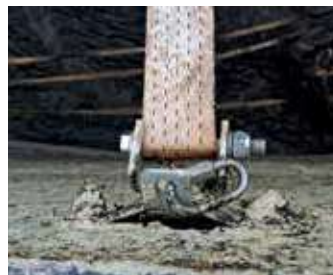
Figure 6: Belt plate, half broken out of the tank wall

fixing plates of a belt was torn out of the tank wall. A significant number of such plates was deformed but still in place, (see Figure 6).

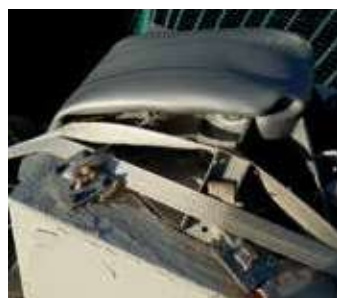
Figure 7: View on the top of the centre column. Massively deformed stainless steel construction. 'Mushroom' bent over to the left. Cracked belt visible on top left of the concrete head of the column

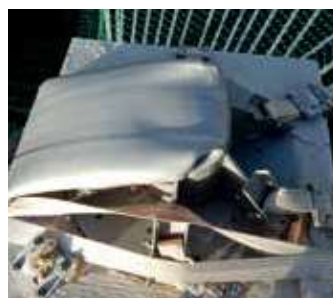
Such additional belts had been fixed fairly well and there was hardly any slack span. This may end up in extra horizontal forces that are effective into the stainless steel construction. Such forces are not included in the structural calculations and every kind of forces that are introduced by the regular 52 belts are also to be taken by the additional six belts. As these six belts are less than half as long as the regular belts, they can absorb lengthening to a significantly lesser extent.

Figure 8: Fixing of the 'additional belts' that have been used for mounting the belt and membranes of the roof structure. Visible are five such belt connections to the stainless steel construction with the sixth one being buried underneath the bent steel structure

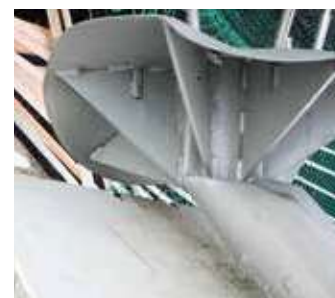
Figure 9: Mushroom head of the stainless steel structure. Bent over the centre column and deformed. On top of the steel structure are visible the sticks that have been used as guidance for the 52 belts laid over the mushroom head
